Collision into Mountainous Terrain
GCI Communication Corp.
de Havilland DHC-3T, N455A
Aleknagik, Alaska
August 9, 2010

NTSB/AAR-11/03
PB2011-910403

Aircraft Accident Report

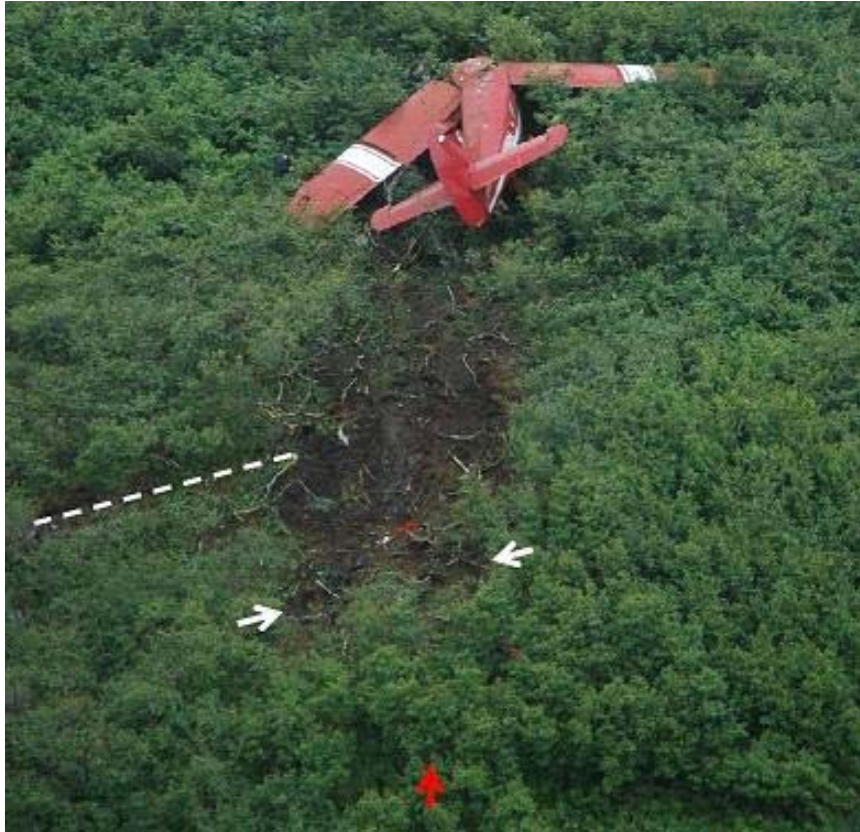
The wreckage path, which extended about 100 feet along a heading of 085° true, began at an area of broken trees (about 8 to 10 feet tall) and was followed by disturbed ground that extended up sloping terrain to the main wreckage. The ventral fin from beneath the airplane's tailcone was the first piece of debris in the wreckage path (found near the initial area of broken trees) and showed tree-strike damage on its leading edge. The slope of the terrain varied from about 30° at the beginning of the wreckage path to about 40° where the main wreckage came to rest. The disturbed ground included two impact areas consistent with the spacing of the airplane's left and right floats. The left wing was displaced aft, and the trees and the ground about 30 feet uphill from the beginning of the wreckage path showed damage consistent with having been struck by the left wing. Figure 8 shows the accident site.

Figure 8. Photograph of accident site.

Note: The red arrow shows where the ventral fin was found, the white arrows show two disturbed ground areas consistent with the spacing of left and right floats, and the dashed line shows tree damage consistent with the span of the left wing.

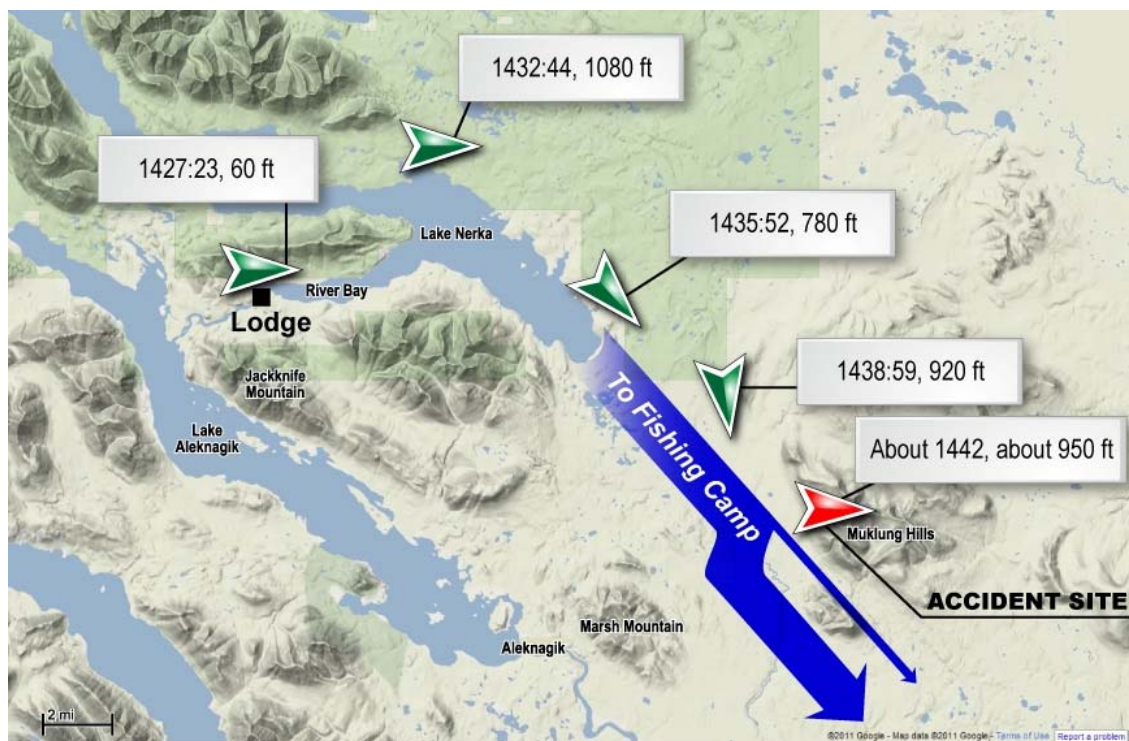
Figure 9. Illustration showing select Sky Connect data for the accident flight and the accident site.

Note: The orientation of each green arrow indicates the airplane's recorded ground track angle; the orientation of the red arrow indicates the approximate heading of the airplane at the accident site.

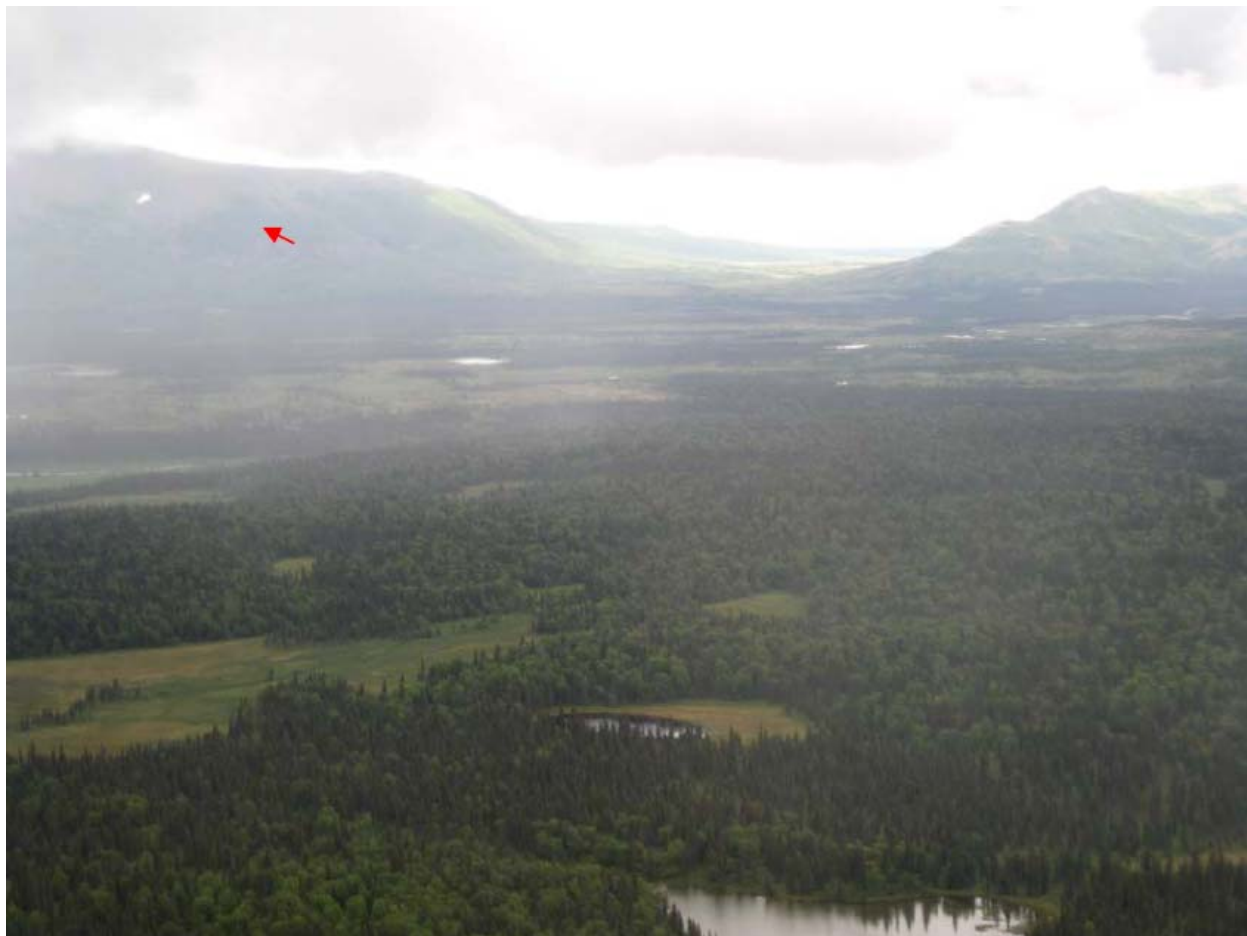
Figure 10. View from about 5 nautical miles south-southeast of Lake Nerka showing the narrow pass near Muklung Hills (view is facing east-southeast).

Note: The red arrow points to the accident site.

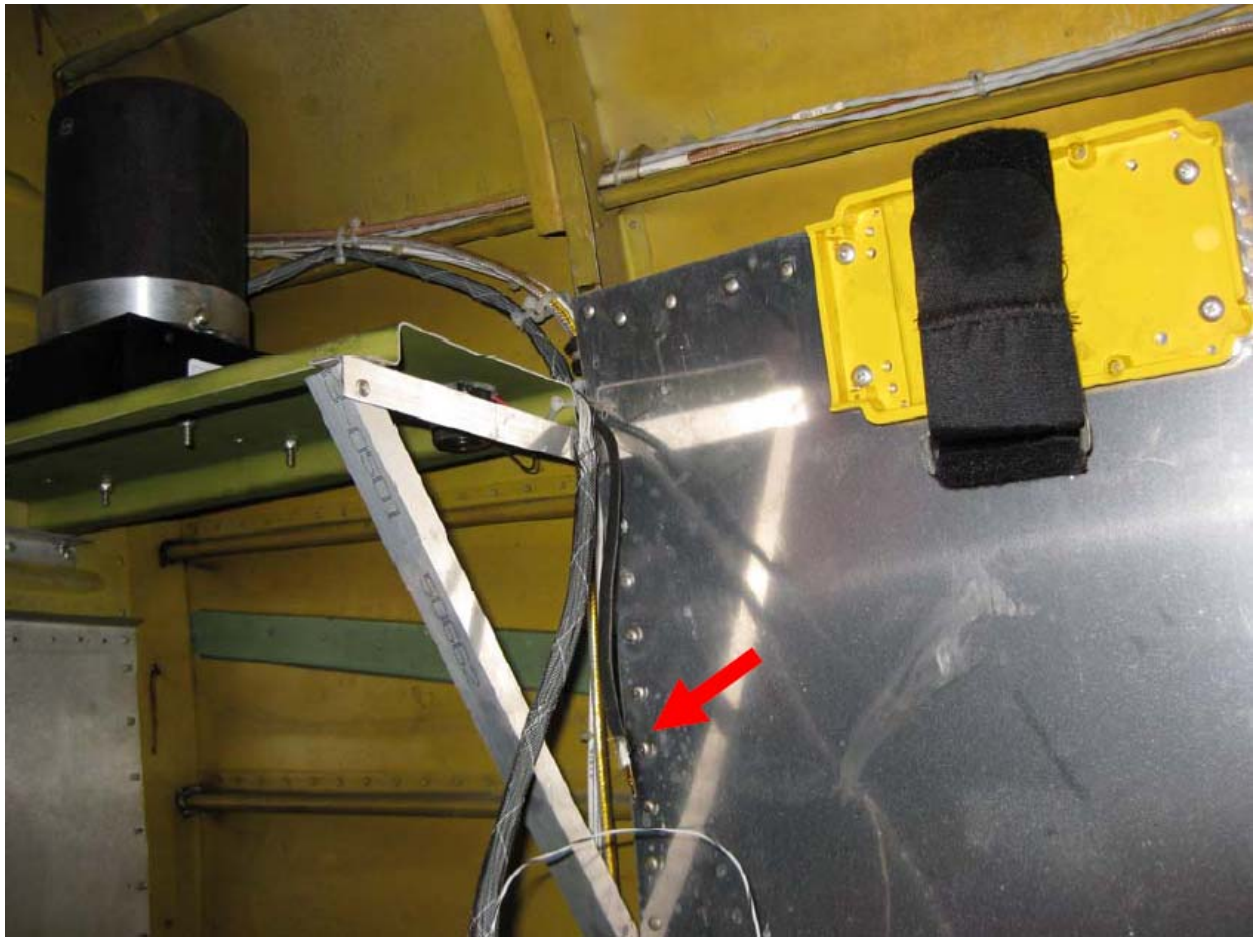
accident airplane's ELT mounting tray was attached securely to the airplane sidewall structure and that the retention strap, which had a hook-and-loop (Velcro®) fastener, was fastened closed, consistent with having been used to secure the ELT unit to the tray. Also, the ELT unit was separated from its remote switch wiring and coaxial antenna cable, which were broken near their connectors. An interior part of the airplane that had been located forward of the mounting tray showed marks consistent with having been impacted by the ELT unit when it dislodged from the tray and the retention strap, which was found secured. Figure 12 shows the accident airplane's ELT mounting tray and retention strap.

Figure 12. Accident airplane's emergency locator transmitter mounting tray and retention strap.

Note: Arrow shows damaged and separated coaxial antenna cable. (Forward is to the left.)
